EXHIBIT C

STATE OF SOUTH CAROLINA)	IN THE COURT OF COMMON PLEAS
)	CASE NO.:
COUNTY OF BEAUFORT)	
)	
Jill Demark,)	
)	
Plaintiff,)	
)	<u>COMPLAINT</u>
-vs-)	(Jury Trial Demanded)
)	
Jetson Electric Bikes, LLC, and)	
Amazon.com, Inc.)	
)	
Defendants.)	
_____)

Per your request, CORE Engineering has completed its engineering analysis of a fire that damaged rental property owned by Jill Demark. The property's address was 66 Mroz Road, Beaufort, South Carolina. The purpose of the engineering analysis was to determine the origin and cause of the fire. This report contains CORE's present findings and opinions. If necessary, CORE will supplement its report to the extent that additional relevant information becomes available.

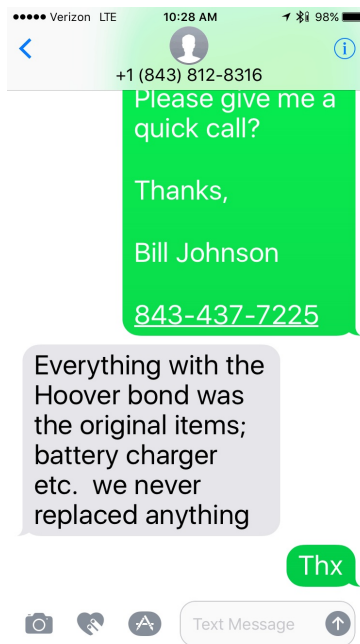
Figure 2 - Screen Capture of Ms. Brown's Text to CORE on March 3, 2018

As stated above and shown in Figure 2, Ms. Brown said the hoverboard's battery charger was the original charger for the subject Glyro hoverboard.

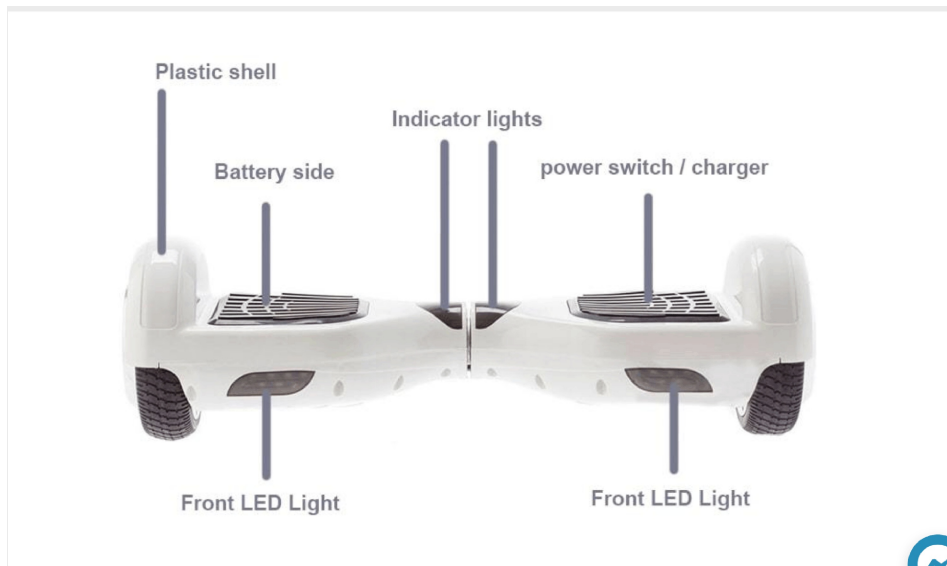
Figure 3 - Hoverboard External Component Nomenclature

Lastly, CORE evaluated a failure of the hoverboard as the fire's ignition source. Figures 3 and 4 show the nomenclature for the components of a typical hoverboard, like the subject Glyro hoverboard.

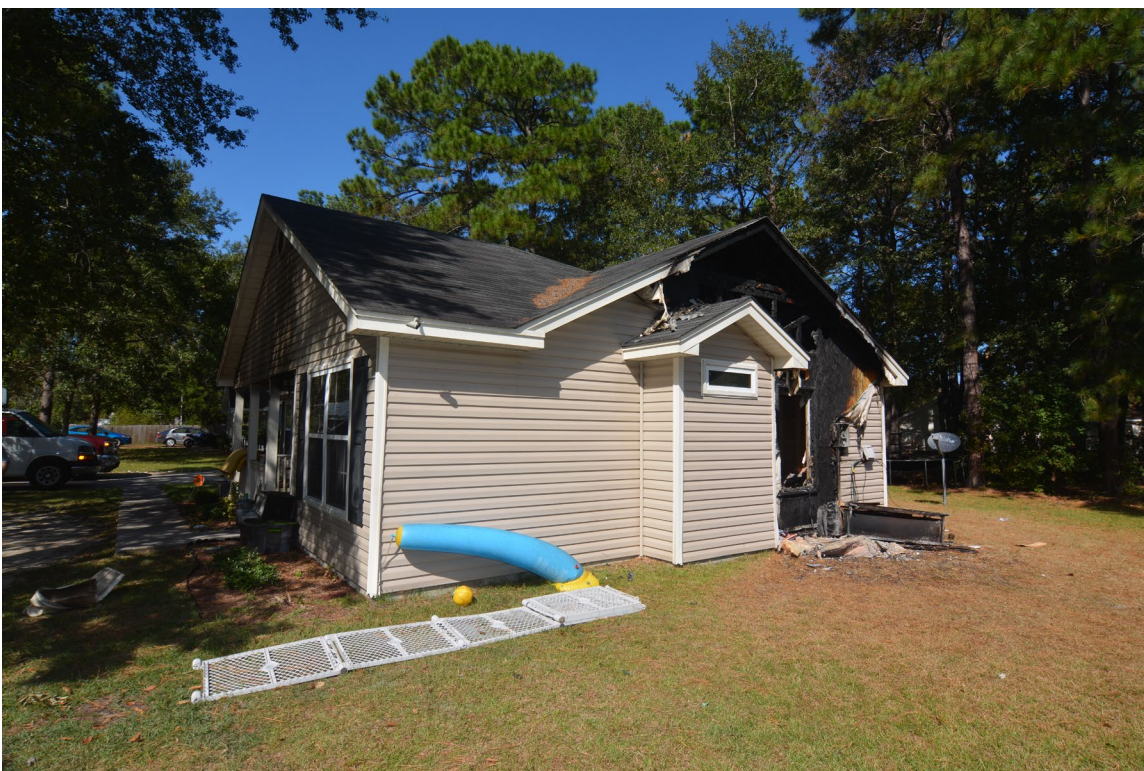
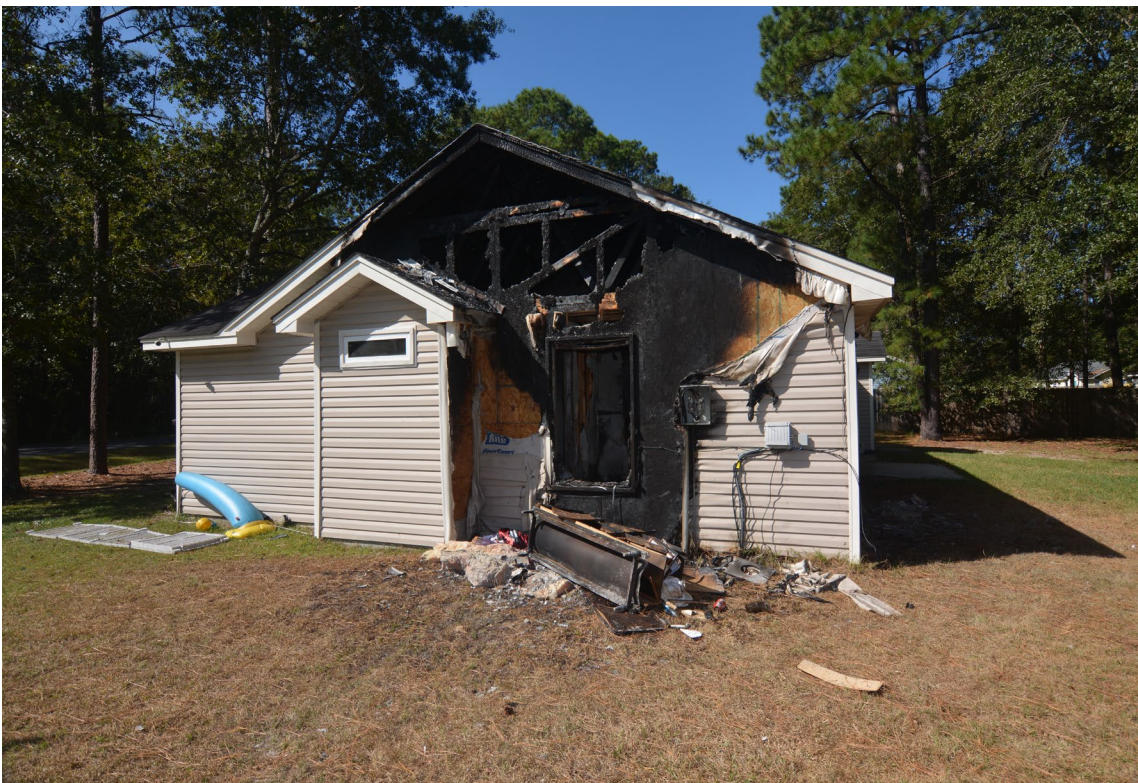
Photographs 5 & 6. Views of the home's northeast quadrant are shown here. The fire vented from Bedroom 1's east and north windows.

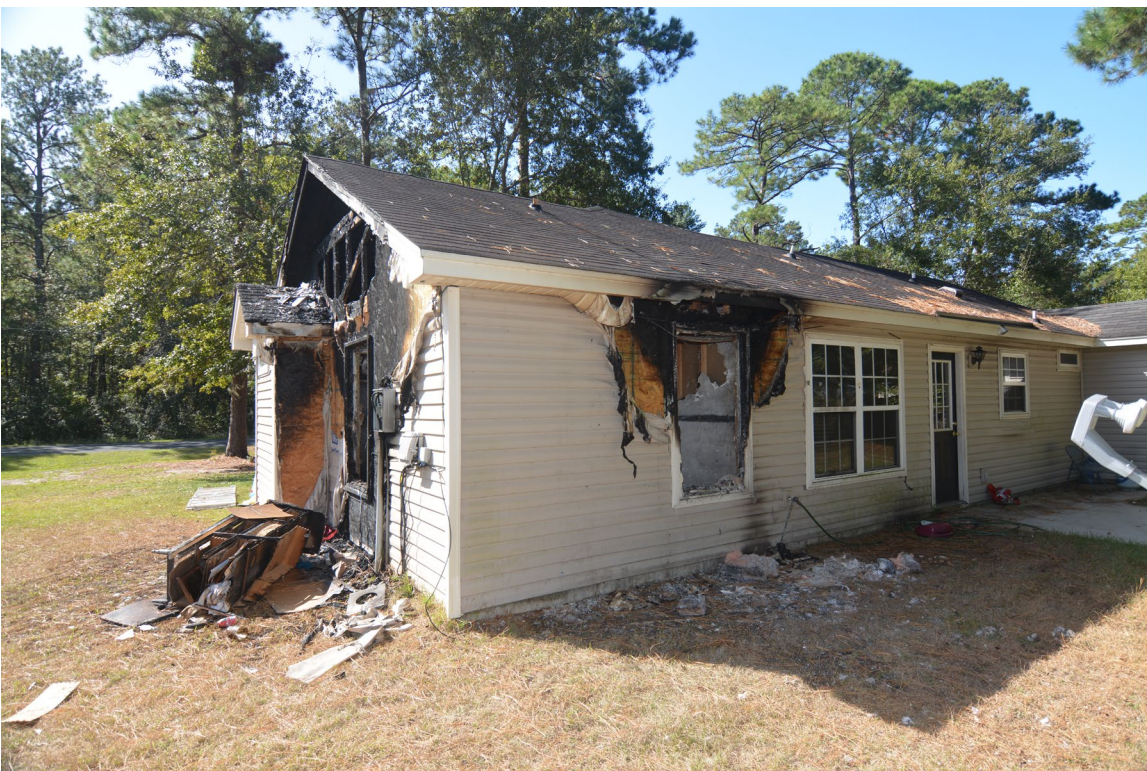
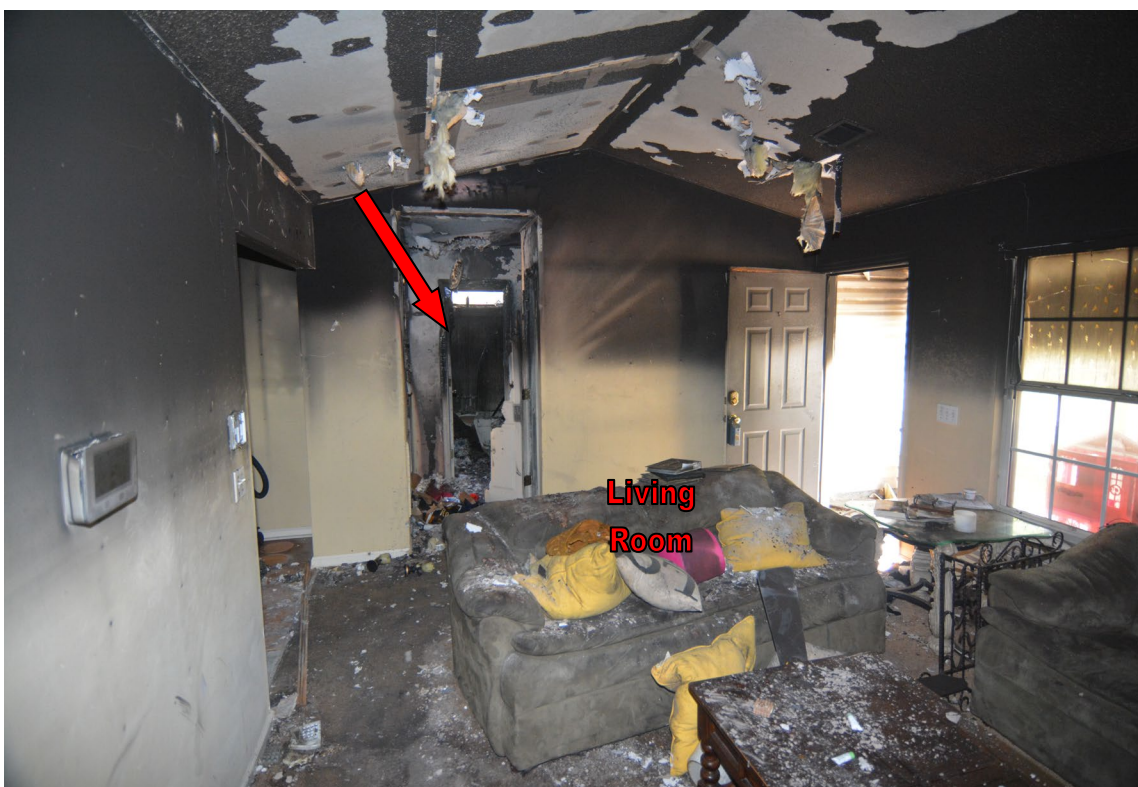
Photographs 7 & 8. A hallway, arrow, on the east side of the living room led to two bedrooms and the hall bathroom. The fire extended from Bedroom 1 into the hallway.

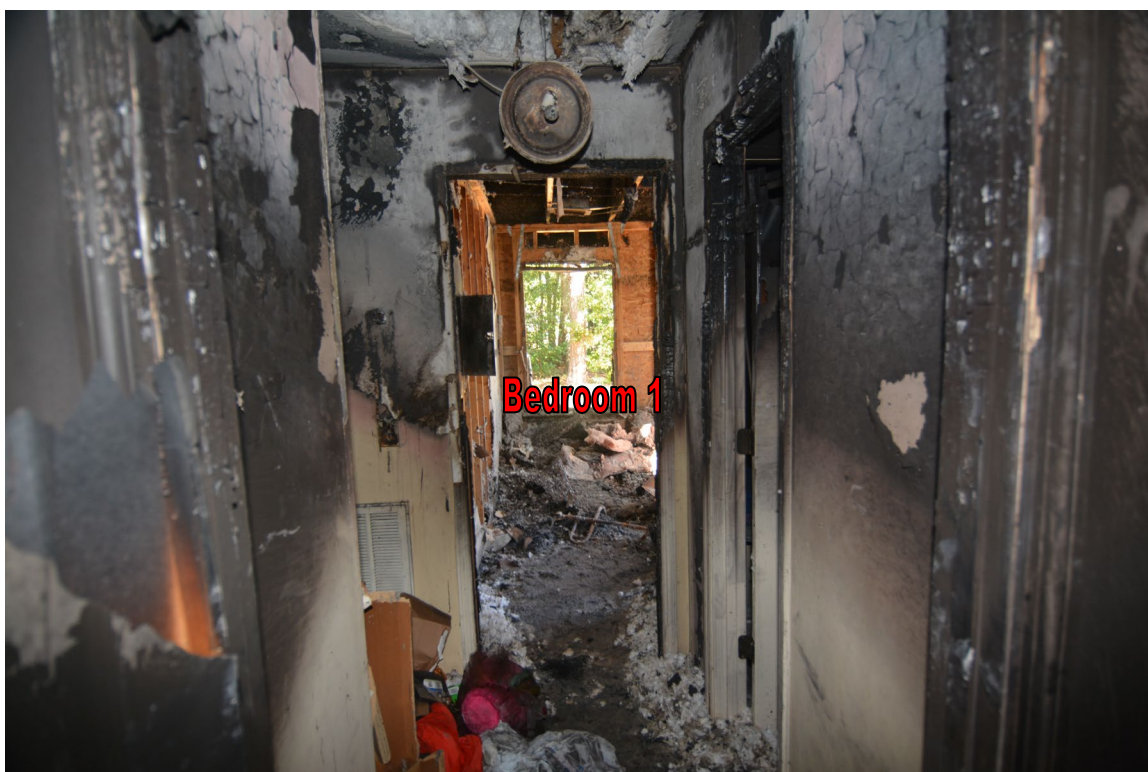
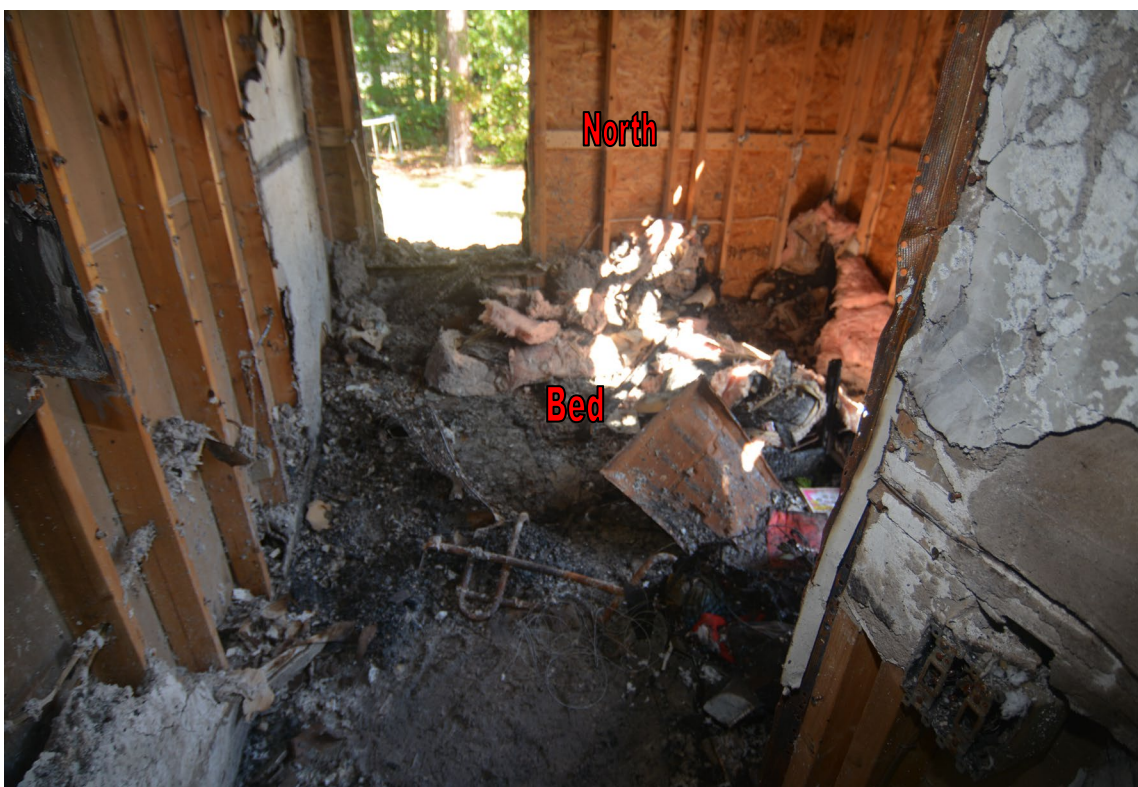
Photographs 9 & 10. Views of Bedroom 1 before scene processing are shown here.

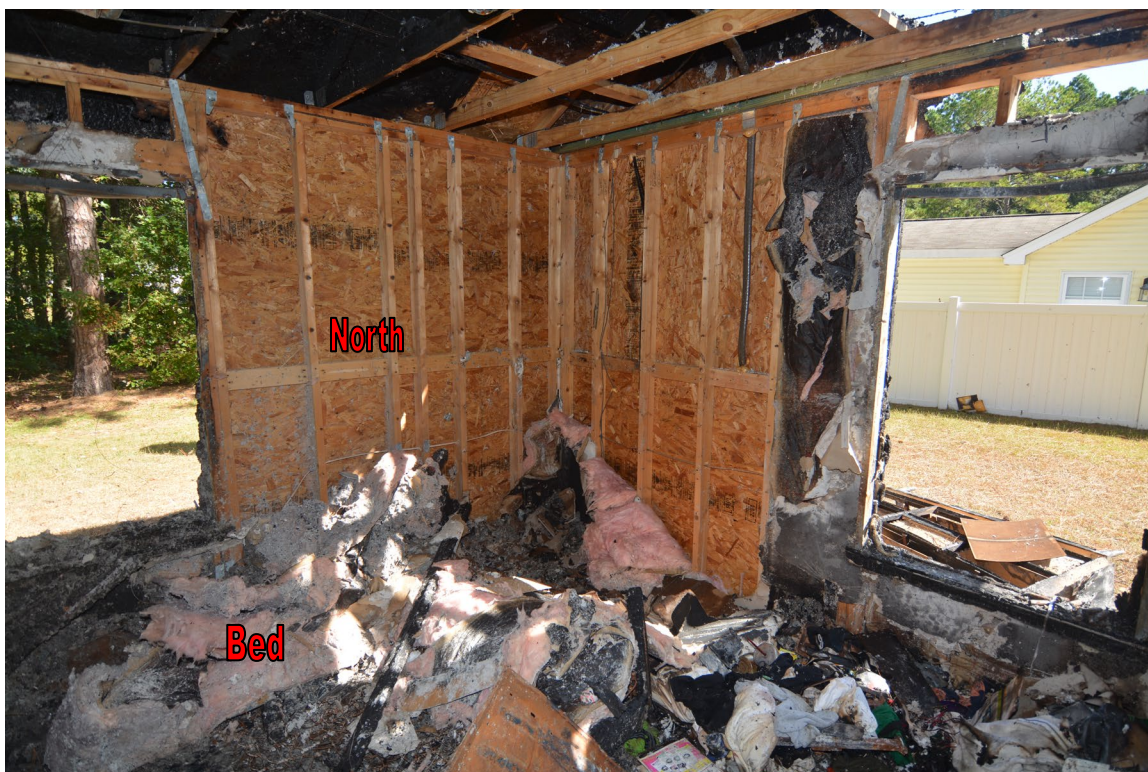
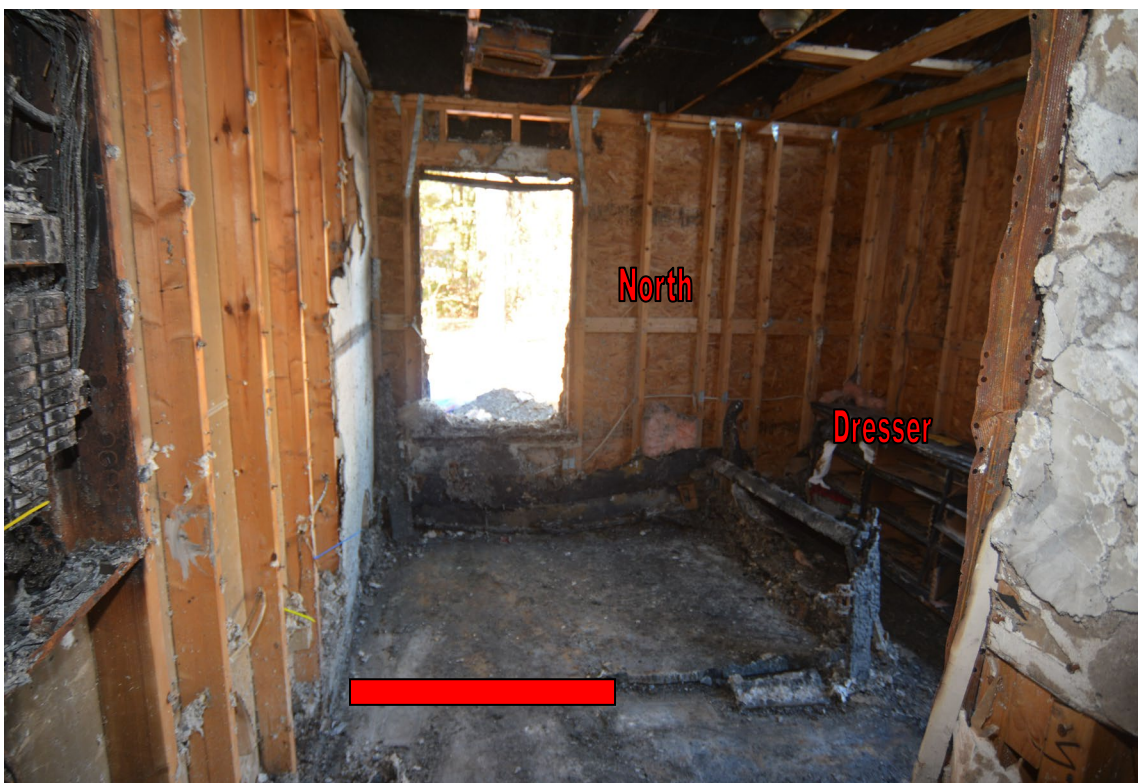
Photographs 11 & 12. Views of the bedroom after processing and debris removal are shown here. A section of the wooden bed frame, red rectangle, was consumed by the fire. The hoverboard was under the bed near the consumed framing.

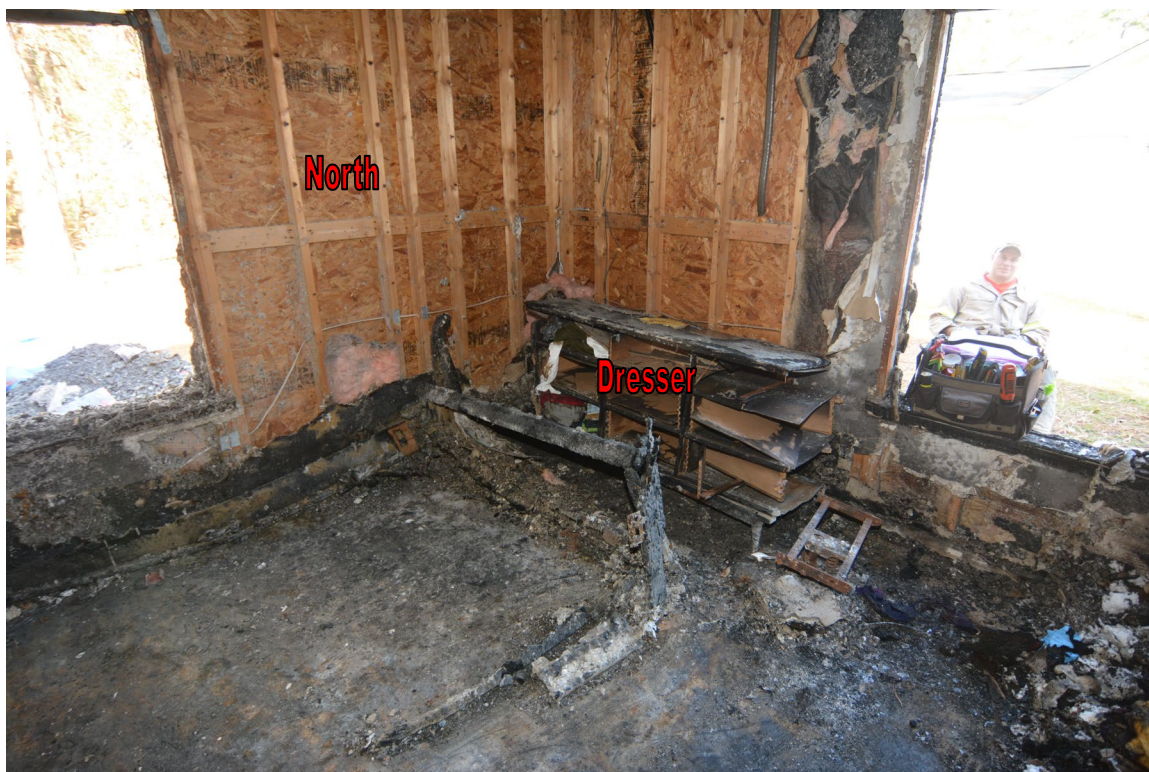
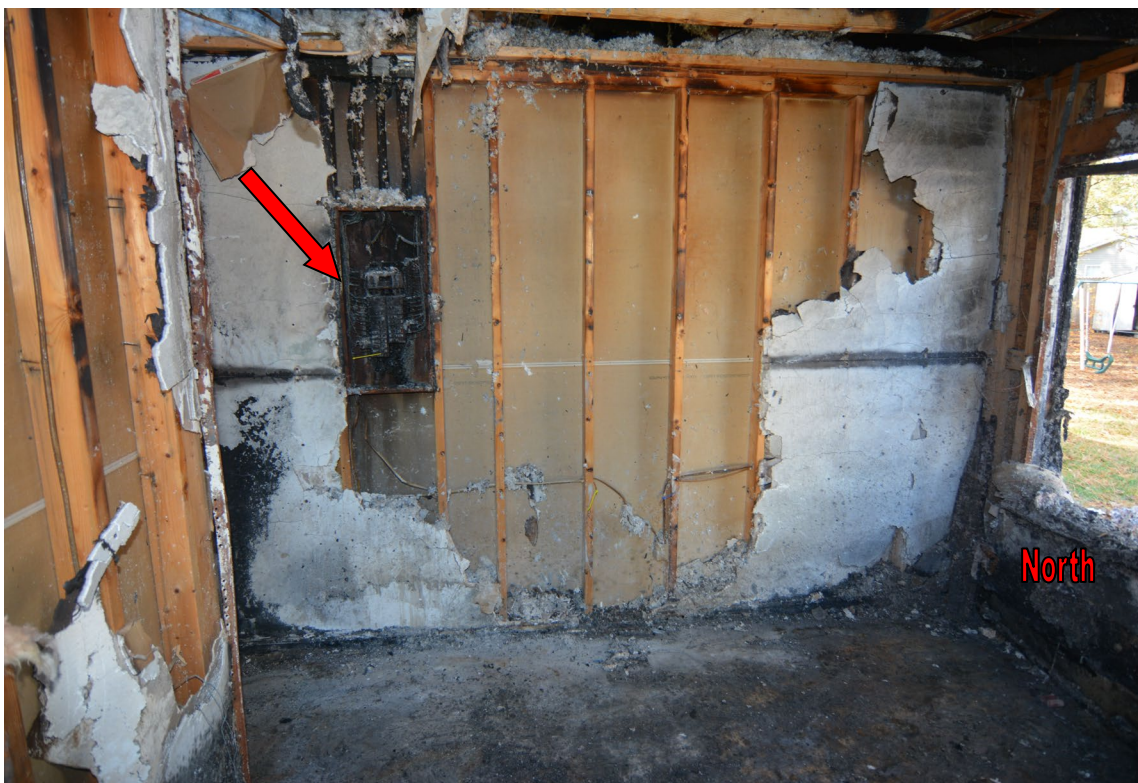
Photographs 13 & 14. Views of the west side of the room are shown here. The Square D panelboard, arrow, was in the west wall.

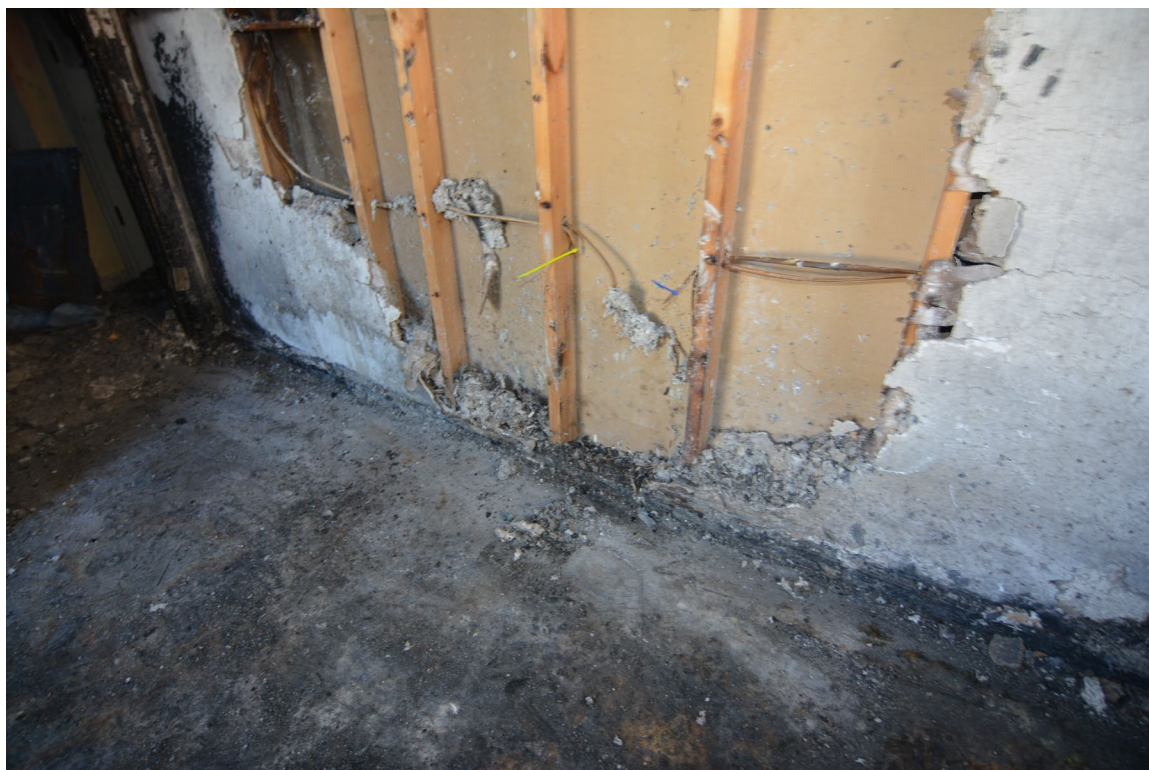
Photographs 15 & 16. The west wall's duplex receptacle's outlet box and segments of its branch circuit conductors are shown above. CORE found the remains of the hoverboard in two sections, below. Carpet remains were adhered to the underside of one of the sections.

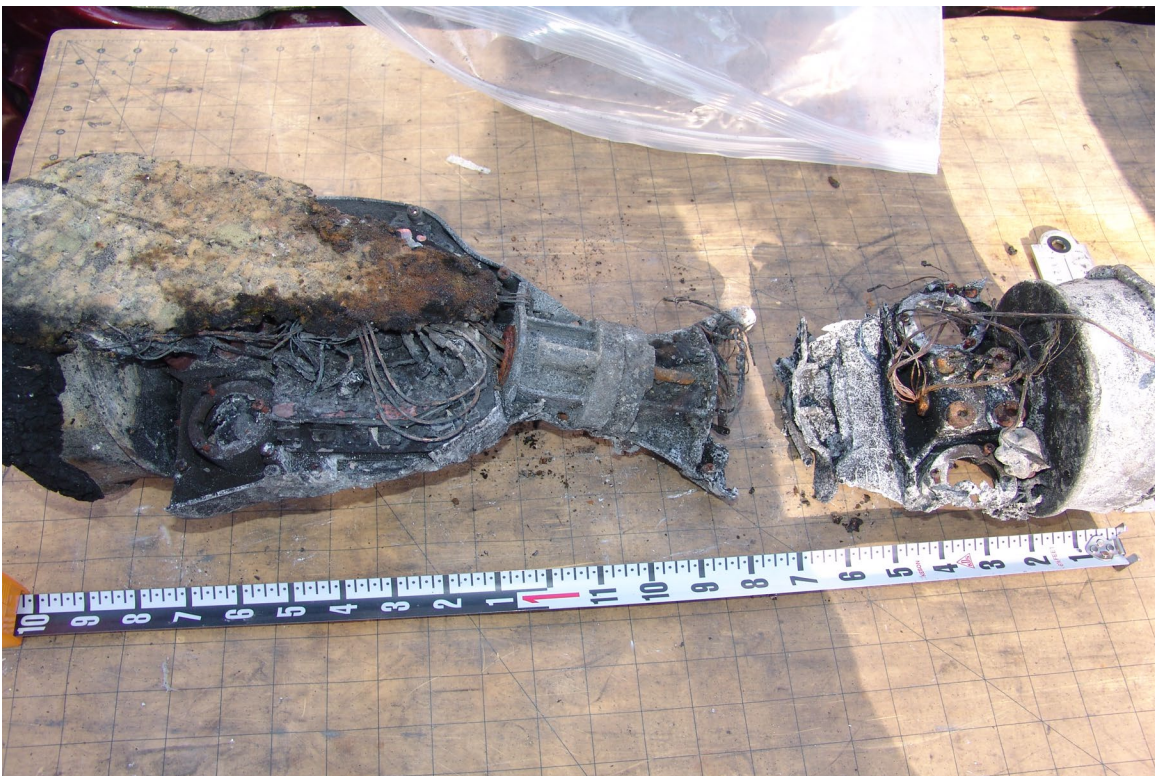
Photographs 17 & 18. Views of the remains of the hoverboard and its conductors are shown here.

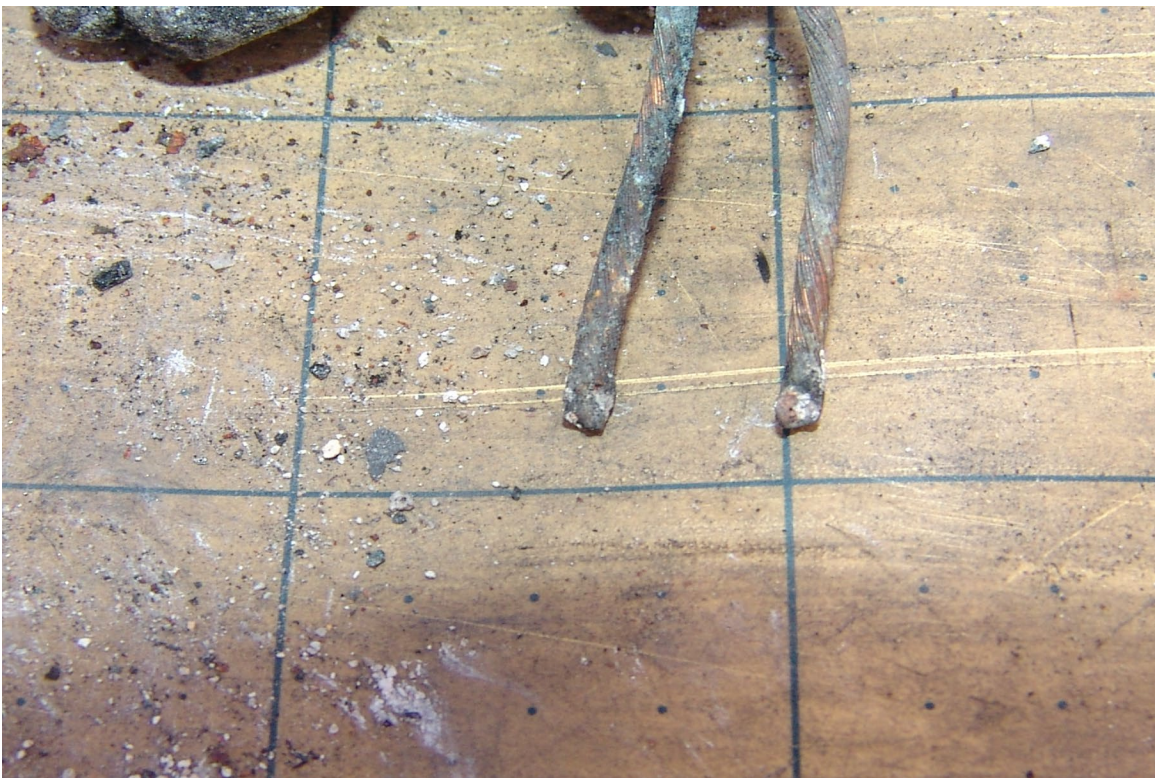
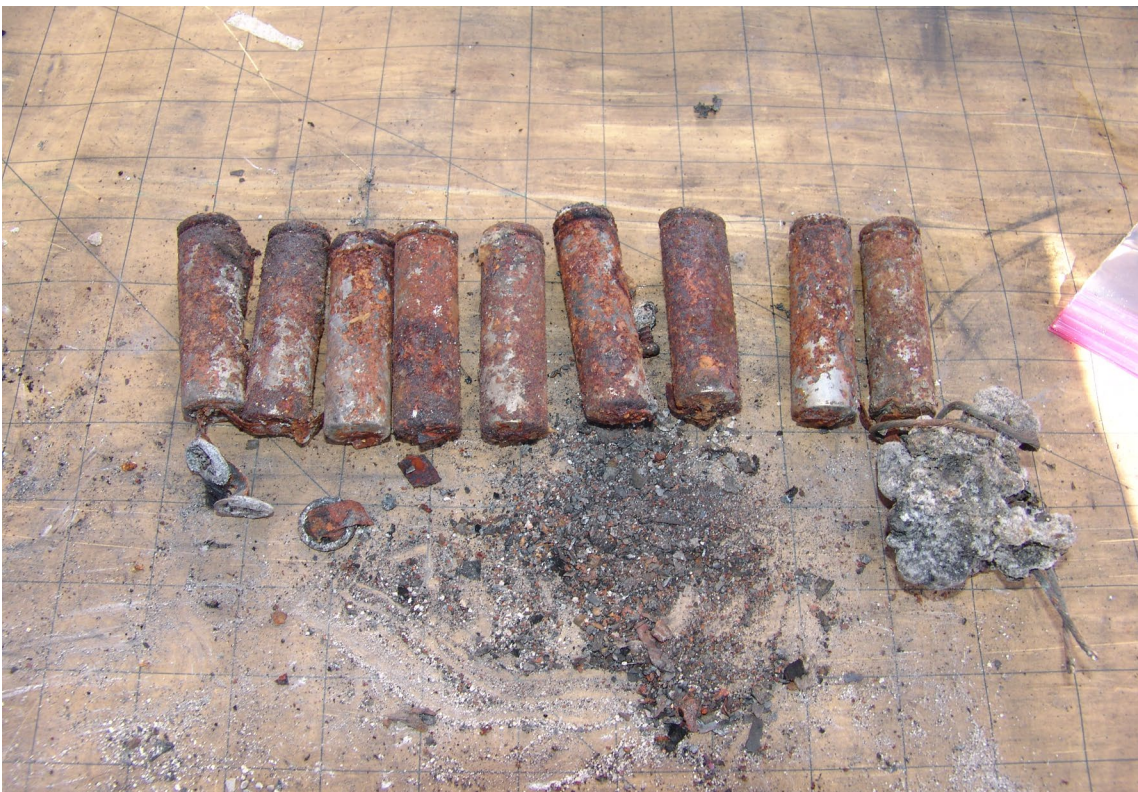
Photographs 19 & 20. CORE found several 18650 lithium ion cells from the hoverboard's battery pack at the site.

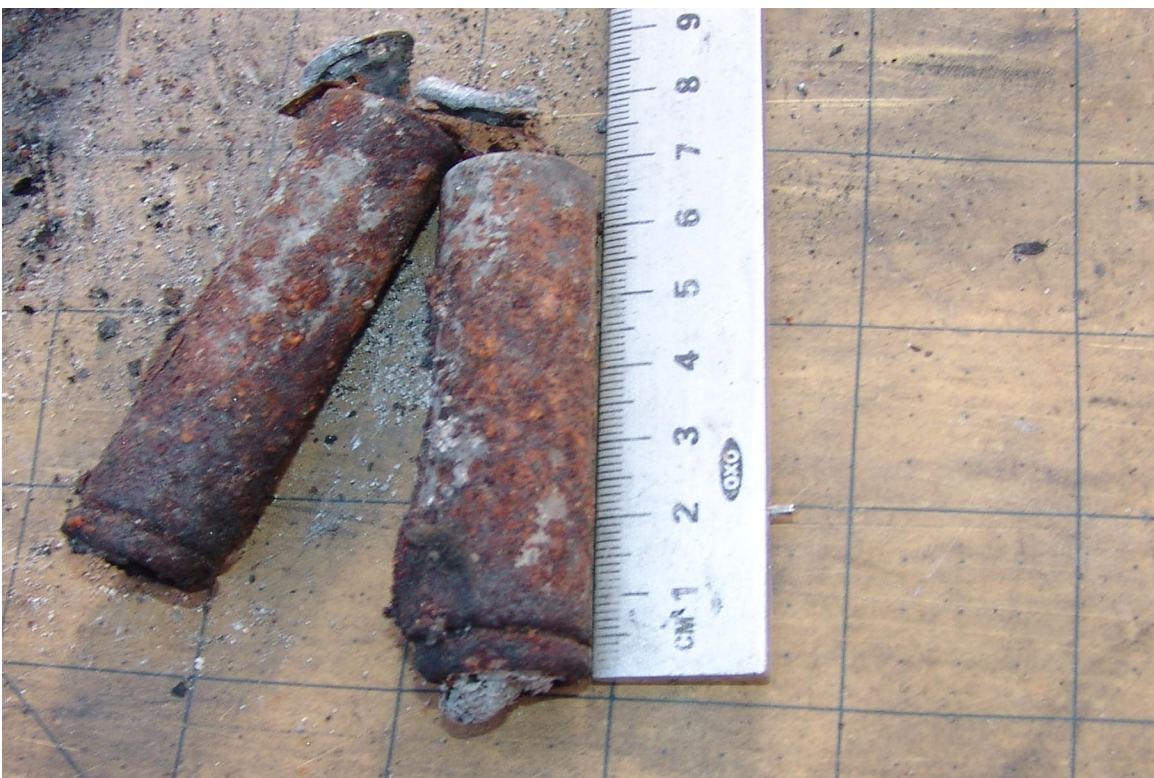
Photographs 21 & 22. Additional artifacts found around the prefire location of the hoverboard are shown above. One of the hoverboard's balance circuit boards, arrow, that was installed next to the battery pack was displaced in the debris field. The remains of a heavily damaged PCB that was similar in size and shape to a typical battery charger's PCB is shown below.

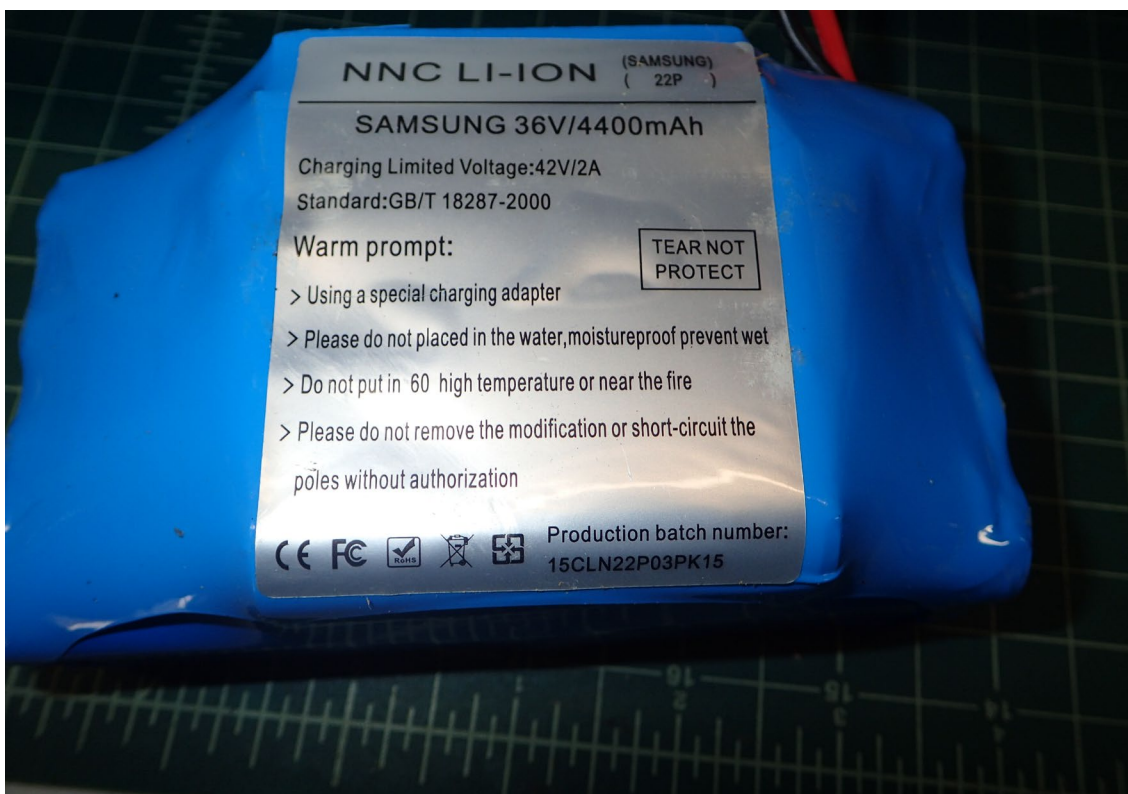
Photographs 27 & 28. The exemplar Glyro hoverboard's battery pack and the markings on some of its 18650 lithium ion cells are shown above and below, respectively.

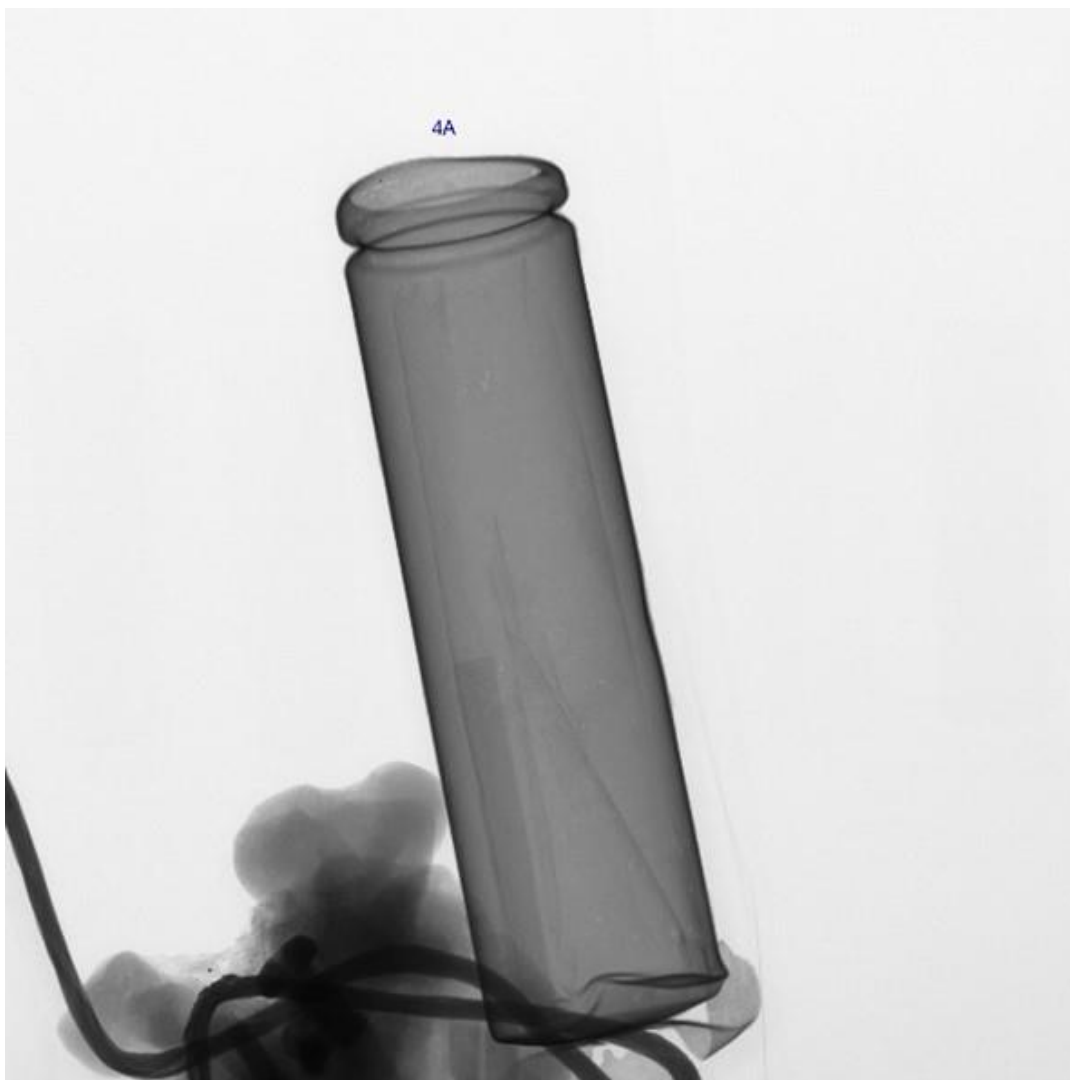
Figure 3. Cell 4A

Figure 3 shows the x-ray image of cell 4A. This image shows that the jelly roll has been ejected and that the cell can shows the rounding of the negative end of the cell and also expansion of the primary or roll crimp at the positive end of the cell can. This is typical of a cell that was exposed to heat and underwent a thermal runaway. It is not a cell that is causal and can be set aside.

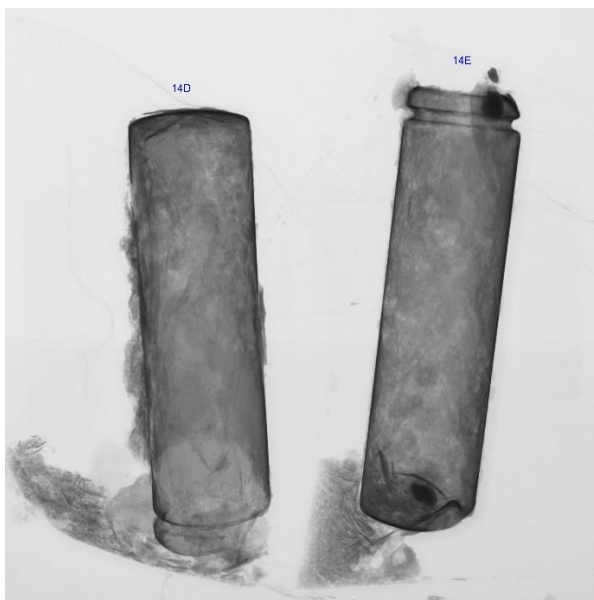
Figure 6. X-ray of cells 14 D and 14 E

Figure 6 shows the x-ray of cells 14D and 14E. Again, these cells have expelled the jelly rolls and exhibit classic signs of being attacked by fire. **Figure 7** shows the x-ray of cell 15A which again appears to be a cell that has been attacked by fire and not an origin.

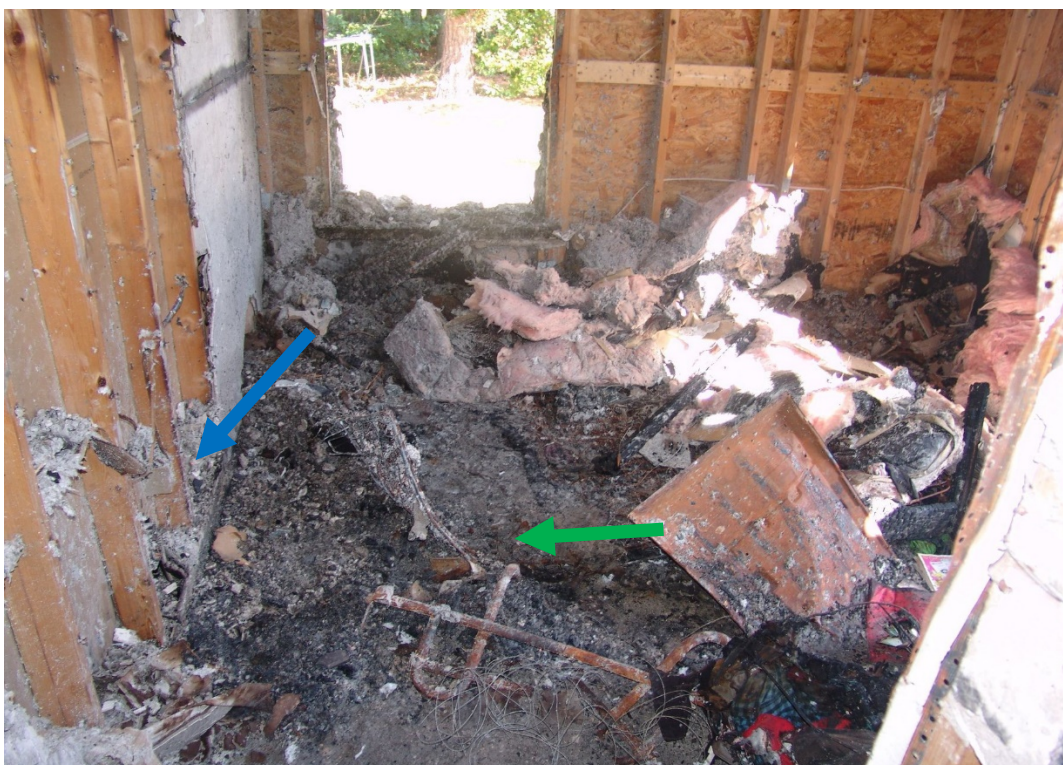
Figure 2: CORE Engineering photograph showing bedroom facing the bed (Green Arrow) with outlet on west wall (Blue Arrow).

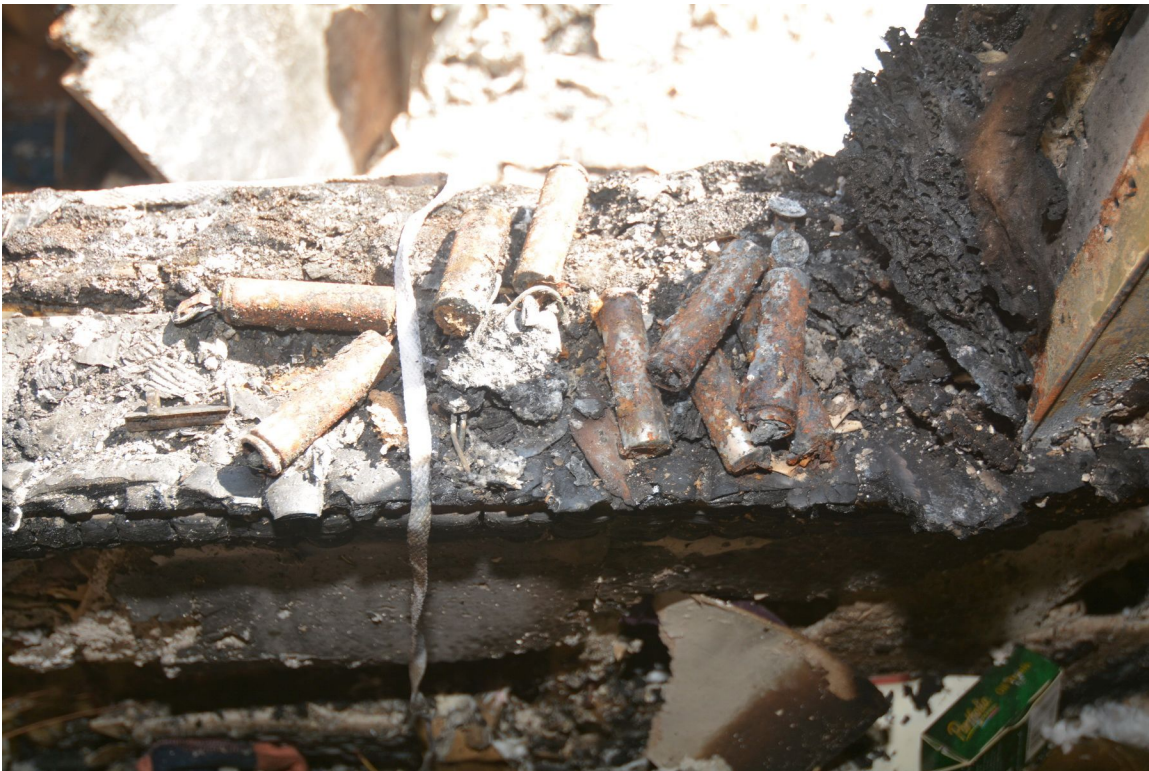
Figure 3: CORE Engineering photograph showing batteries on windowsill.

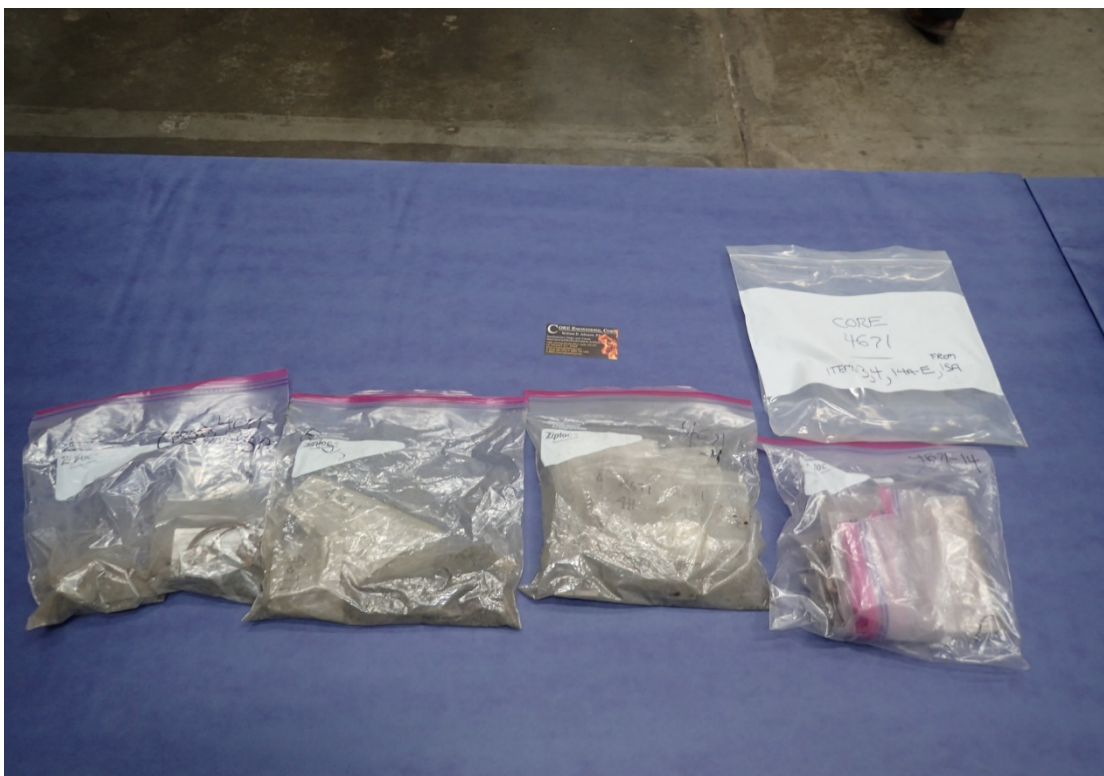
Figure 4: Remains of battery cells from subject hoverboard and other items recovered from the Denmark property.

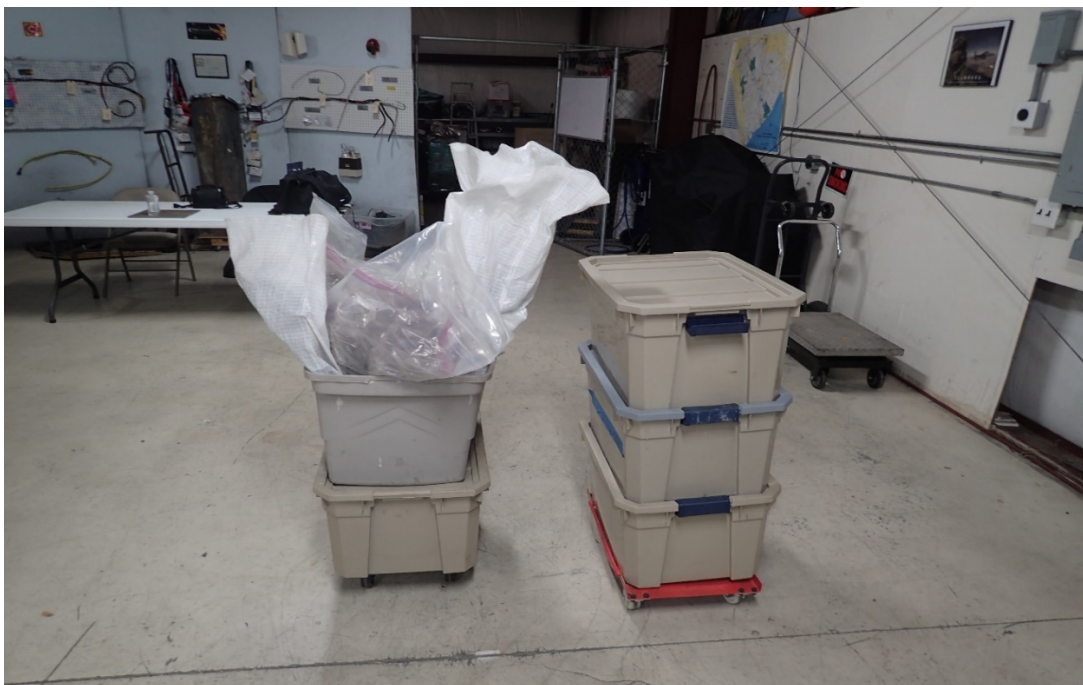
Figure 5: Artifacts recovered from the Denmark property fire.

All the artifacts (as shown in **Figure 4** and **Figure 5**) were examined in detail during the joint laboratory examinations. While all the items were examined, items of particular interest in the area of fire origin determined by CORE Engineering were as follows:

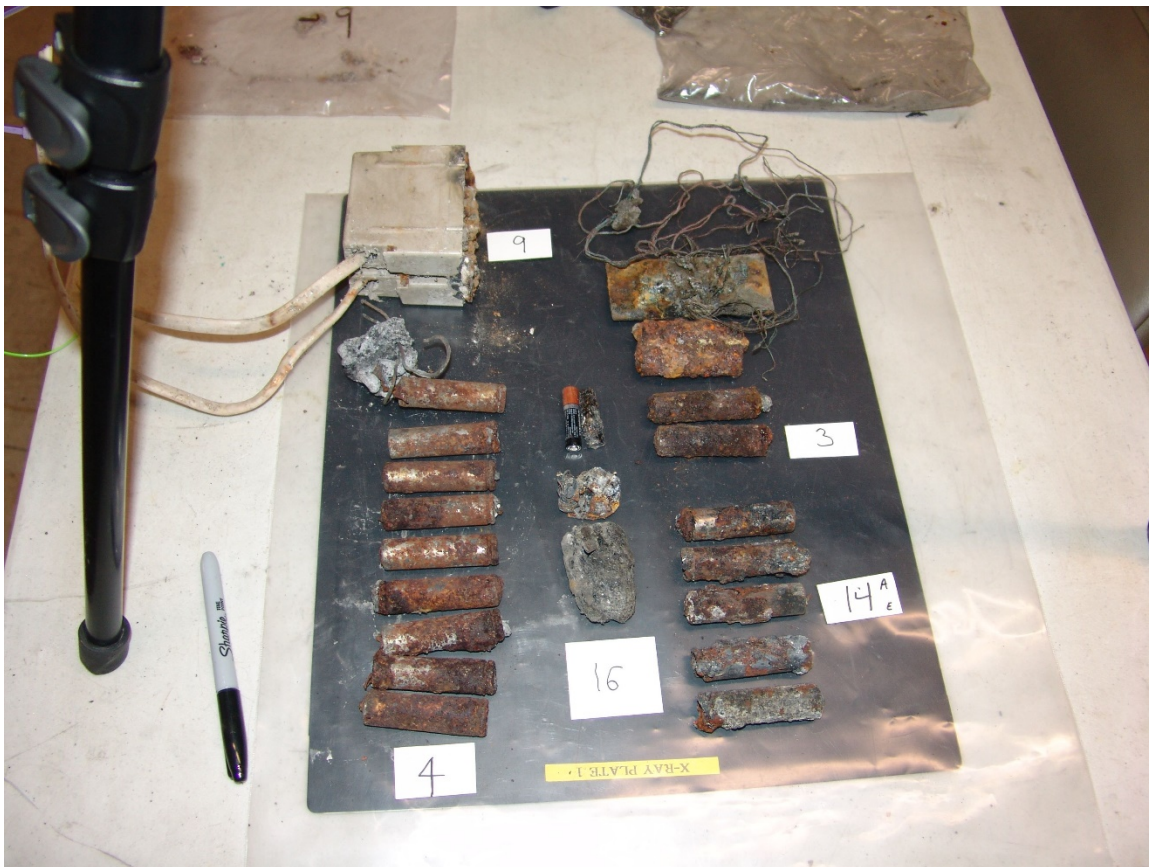
Examination of the remains of the cylindrical 18650 battery cells revealed designations of numeric-alpha identifiers. Several battery cells exhibited a vented event that ejected the electrolytic roll of the battery cells or dislodged the vent cap. Close examination of the battery cells revealed this ejection was consistent with the battery cells being attacked by fire, but with no evidence of arcing and shorting on the steel casing for any of the cells as seen in **Figure 6** through **Figure 12**.

Figure 6: CORE Engineering photographs showing the battery cell remains, the outlet, and the balancing board circuit board and wiring.
